# River Restoration Planning

Diego García de Jalón  
Marta González del Tánago

## River Jarama flow regime

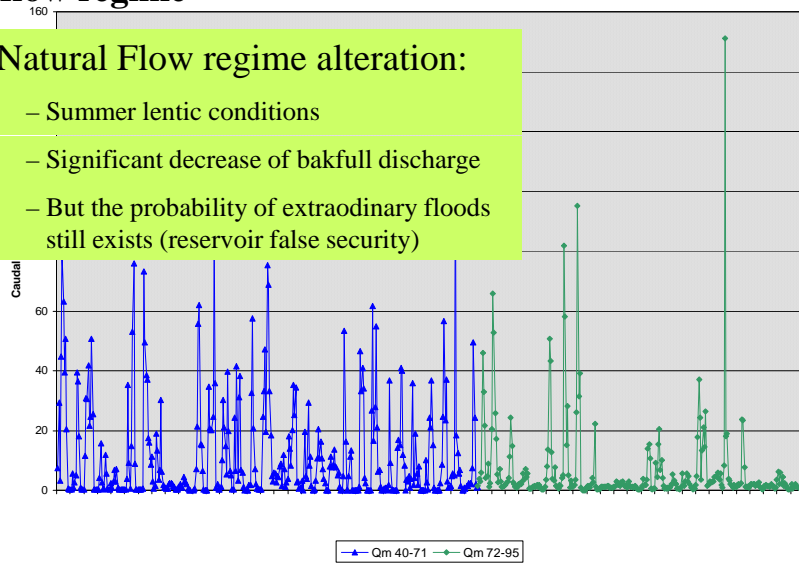
River Jarama Mean monthly flow values from 1940-95. Blue line before the construction of large reservoirs (El Atazar, Pinilla & El Vado)

- Natural Flow regime alteration:

- Summer lentic conditions
- Significant decrease of bankfull discharge
- But the probability of extraordinary floods still exists (reservoir false security)

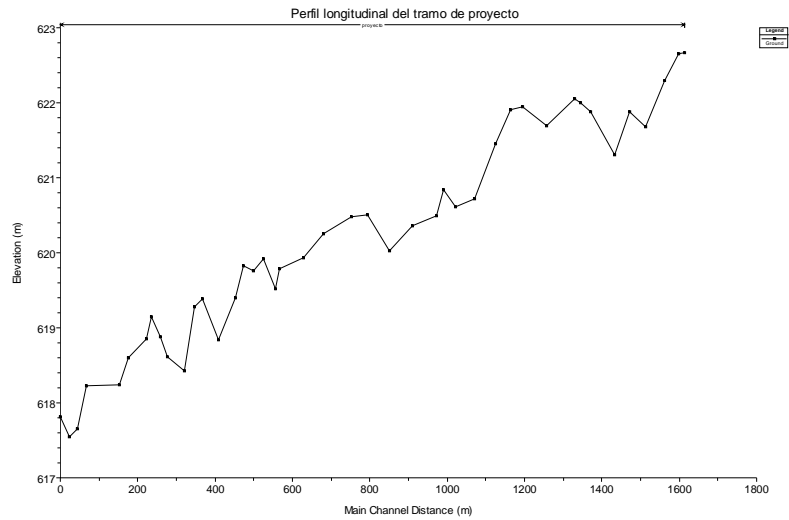
Longitudinal profile of the project reach (43 sections)

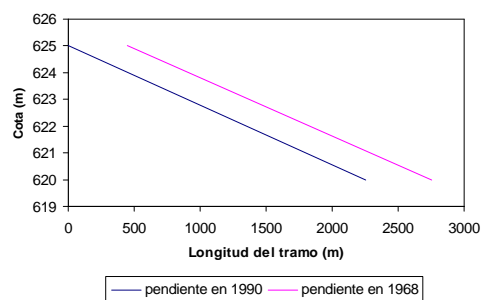
### Longitudinal Profile

River Jarama base level lowered due to:

- Gravel extractions directly from river bed, and also from the riparian system
- Decrease of bed load and transported sediments

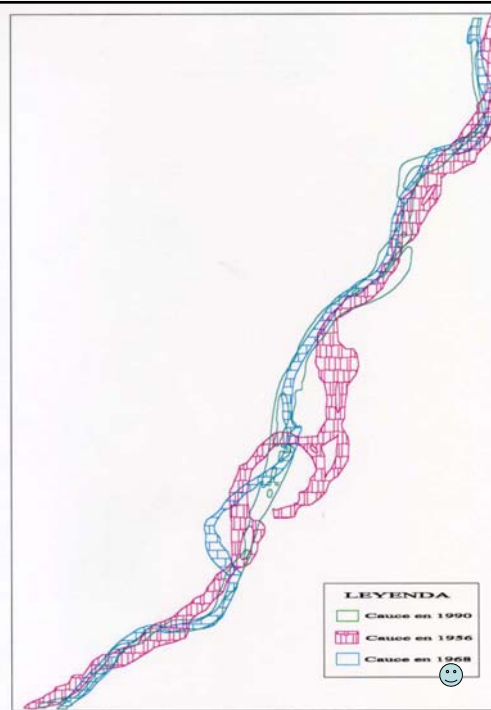
## Project reach Plant view

Planta presentada por el cauce en el tramo de estudio en 1956, 1968 y 1990 a través de los planos 1:5.000 de 1990 y 1968 y la fotografía aérea de 1956.

Historical evolution:

- Sinuosity
- Surface
- Channel width

Años	Sinuosidad	Longitud (m)	Superficie (ha)	Anchura del cauce (m)
1956	1.2	3500	18.69	53.39
1968	1.125	3100	9.154	29.53
1990	1.04	3000	11.72	39
